# **Safety Reports Series**

No. 17

LESSONS  
LEARNED FROM  
ACCIDENTAL  
EXPOSURES IN  
RADIOTHERAPY

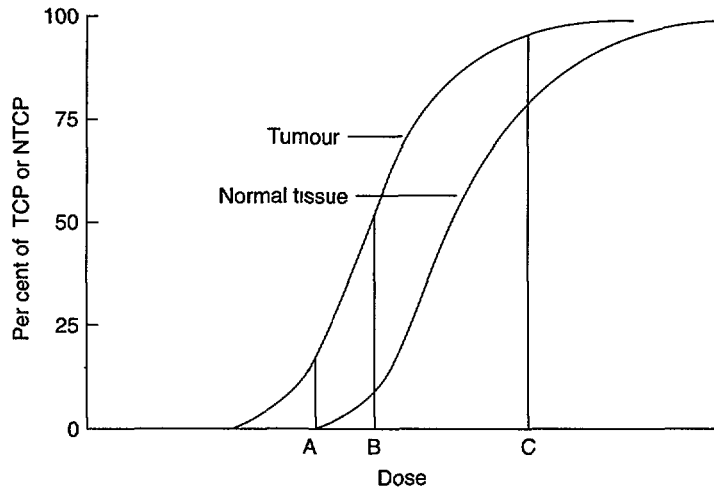
It is worth taking a more detailed look at Fig. 1: the slope of the sigmoid curves is usually steep. In the simplified example, if the maximum is situated at a dose where the slopes of the sigmoids are near 2, a deviation of 15% means a decrease in TCP or an increase in NTCP of 30%, which may jeopardize the justification of the decision made. However, this is only one example and the slope of the curves varies depending

*FIG. 1. Tumour control probability (TCP) and the probability of normal tissue injury as a function of radiation dose, in a hypothetical case. If normal tissue injury is to be avoided altogether, the radiation dose cannot exceed A; the TCP is low. By accepting a relatively small probability of normal tissue injury, the radiation dose can be increased to B, and the TCP is significantly improved. A further increase in the radiation dose above C results in an increased complication rate with very little improvement in TCP.*
